SALT CONTAMINATION OF PRIVATE WELL WATER SUPPLIES

TOWN OF WHITCHURCH — STOUFFVILLE
COMMUNITY OF BALLANTRAE

SALT CONTAMINATION OF PRIVATE
WELL WATER SUPPLIES

JANUARY 1977

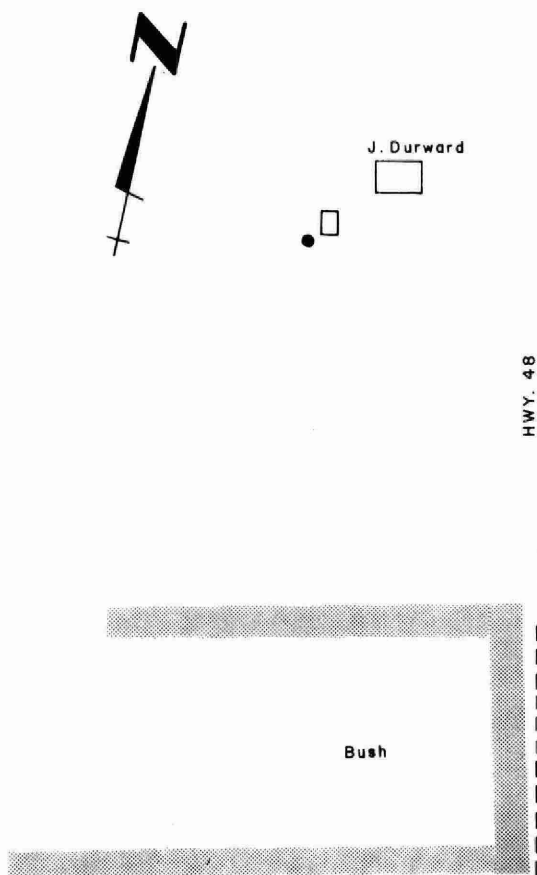
FIG. 2

From the levelling survey, using the dug portion of the Powell well and the abandoned well W_A as control points, the groundwater flow direction in the upper aquifer (Figure 2) is south-west; from the problem area towards the subdivision south-west of the intersection. At the time of the survey, the Giasson new well and the Stone well were being used. Thus it is felt that they do not represent equilibrium conditions. It should be noted that the gradient between the control points was very small (.0046 ft/ft). MacArthur (3) in 1972" demonstrated the local water table to be relatively flat" in the area south of the intersection.

During the levelling survey, five points along the bottom of the ditch on the west side of Highway 48 were levelled (Figure 2). The survey showed that culverts in the ditch slope to the north but a high point exists in the ditch bottom which would prevent water from draining in this direction. In effect an area where salt laden water would pond in the spring has been created. This ditch was

Three other wells show elevated levels of chloride; these being the Stone, abandoned (W_A) and Davis wells. The Stone well is directly downgradient from Country Road 15 and as can be seen in Figure 2 has a drainage ditch constructed in front of the house which turns south and runs beside the house. It is interesting to note that the abandoned well has a lower chloride concentration than the Stone well. The difference is probably due to the difference in depth between the two wells and the fact that the abandoned well is not pumped.

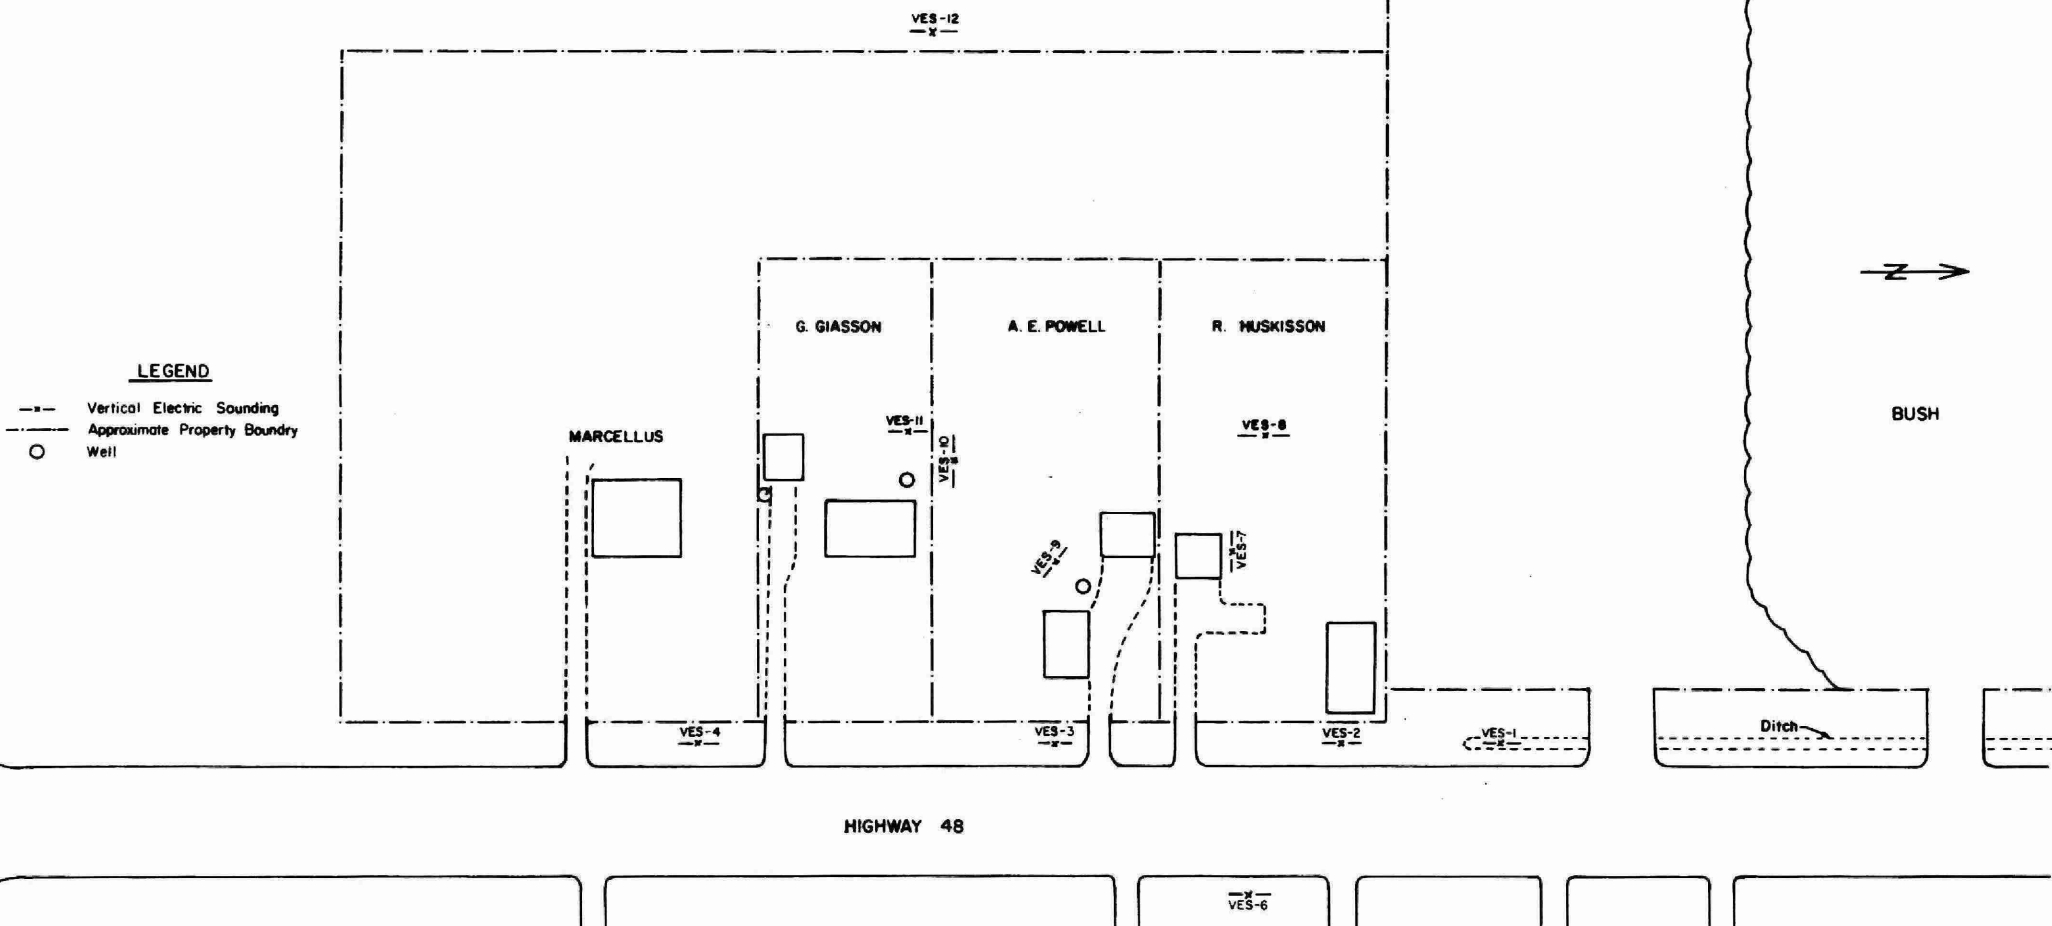
FIGURE 1

At your request a resistivity survey was carried out in the Community of Ballantrae to determine whether road salting operations along Highway 48 had resulted in a deterioration of water quality in three wells at Ballantrae.

The chloride concentration of 1000 ppm and conductivity of 3,000 micro-mhos/cm in one of the wells was considered high enough to enable the zone of the contamination to be mapped by the resistivity technique. Twelve vertical electrical soundings (VES) were carried out using the Wenner electrode configuration. Figure 1 shows the general layout of the area and the location of the soundings. The contaminated wells are those of Messrs. Muskisson, Powell and Giasson. The results of the soundings are shown in Figure 2 and are plotted in three groups for comparison. Groups 1 and 2 show the sections across the highway and group 3 shows the section parallel to it.
